Hot Corrosion of Single-Crystal NiAl-X Alloys

James A. Nesbitt
Lewis Research Center, Cleveland, Ohio

National Aeronautics and
Space Administration

May 1998

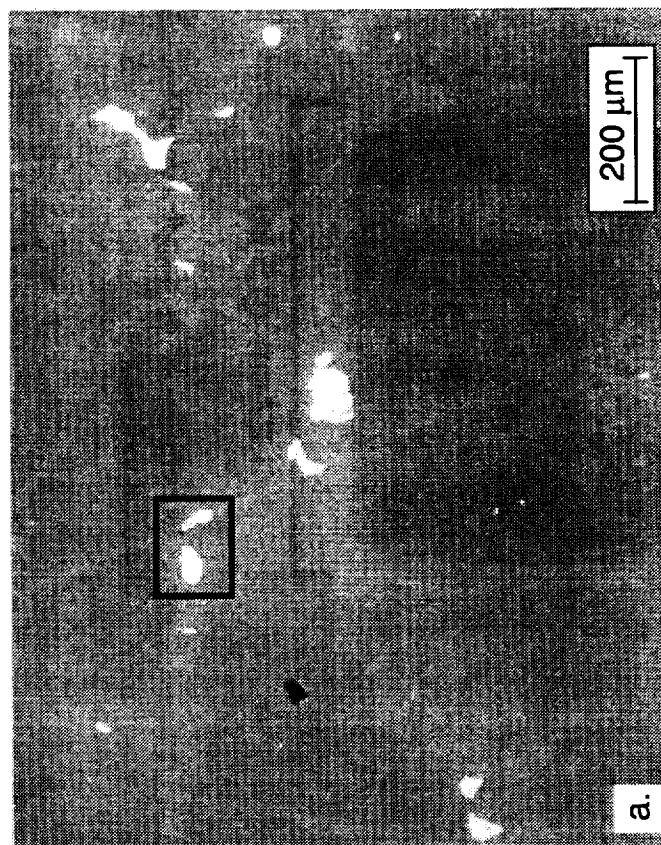
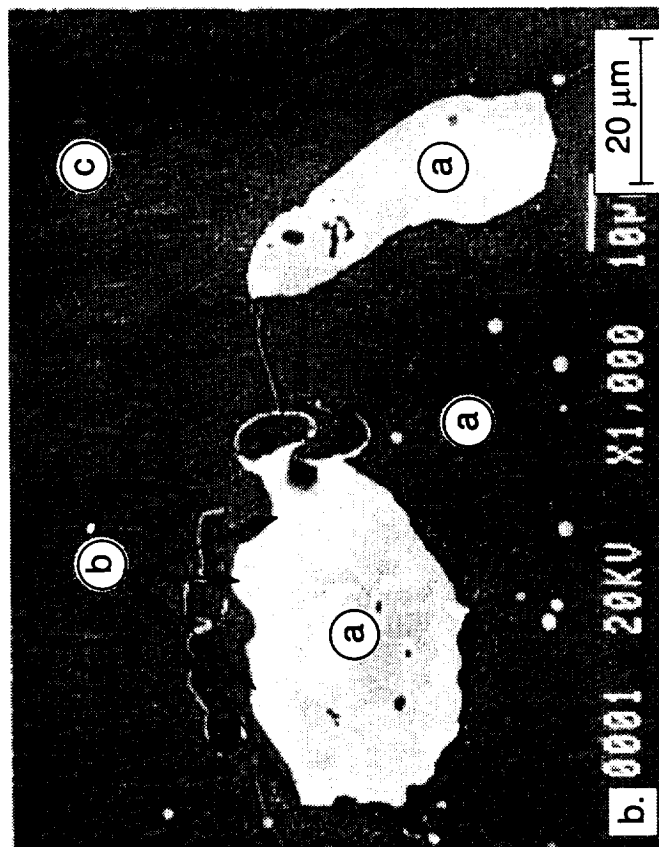
Location	Ni	Ti	Al	Hf	Si	Phase
a	49.0	16.0	28.4	5.8	0.7	Heusler
a (2nd spot)	49.2	15.0	31.5	3.5	0.7	Heusler
b	35.2	13.4	0.7	19.0	31.7	NiHfSi
c	49.0	7.1	42.9	0.7	0.2	β - NiAl, Matrix

Fig. 1 Large multiphase precipitates found in all alloys except D218. Compositions in the table refer to labeled points a-c in the image.

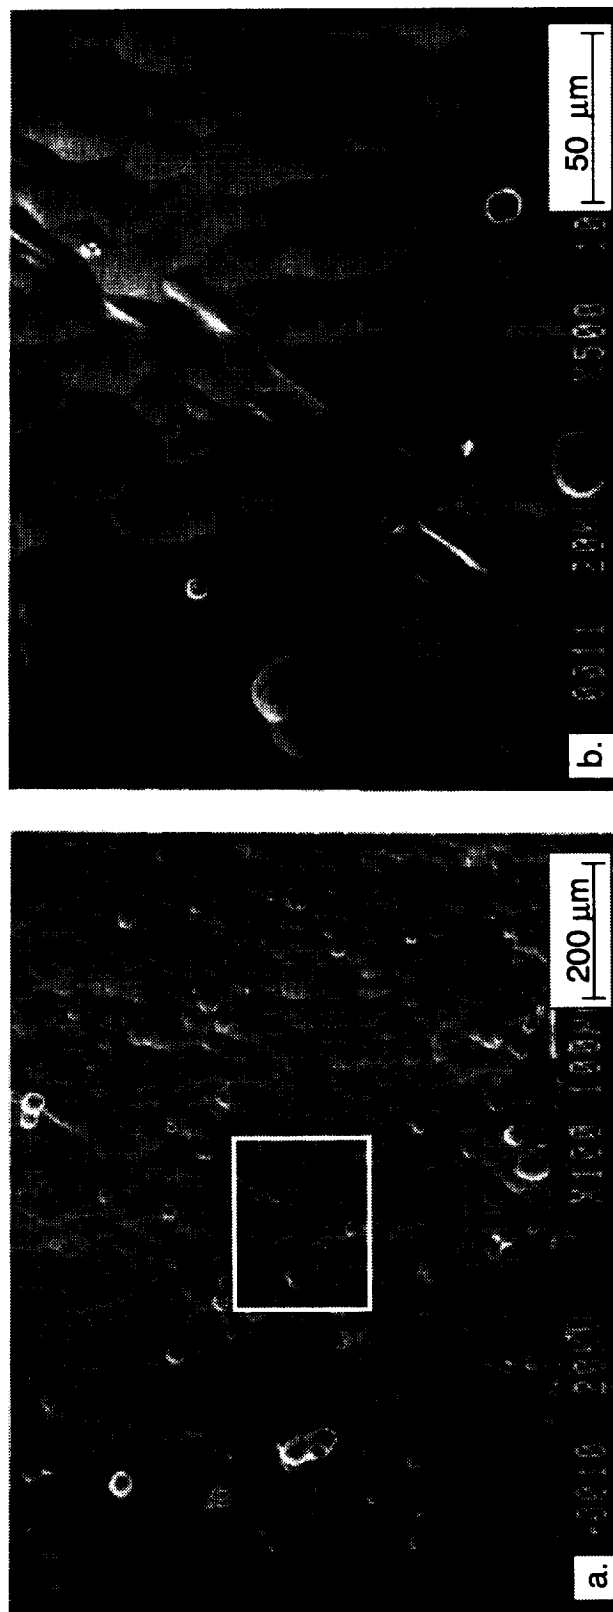
Fig. 14 SEM photos of the surface of D218 after chemical milling (a) general surface features, (b) high magnification of inset in (a) showing unidentified linear feature.

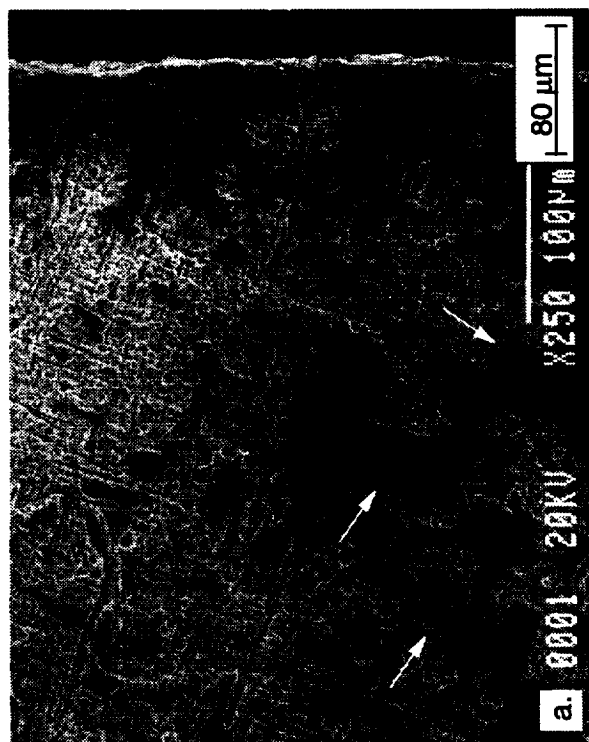
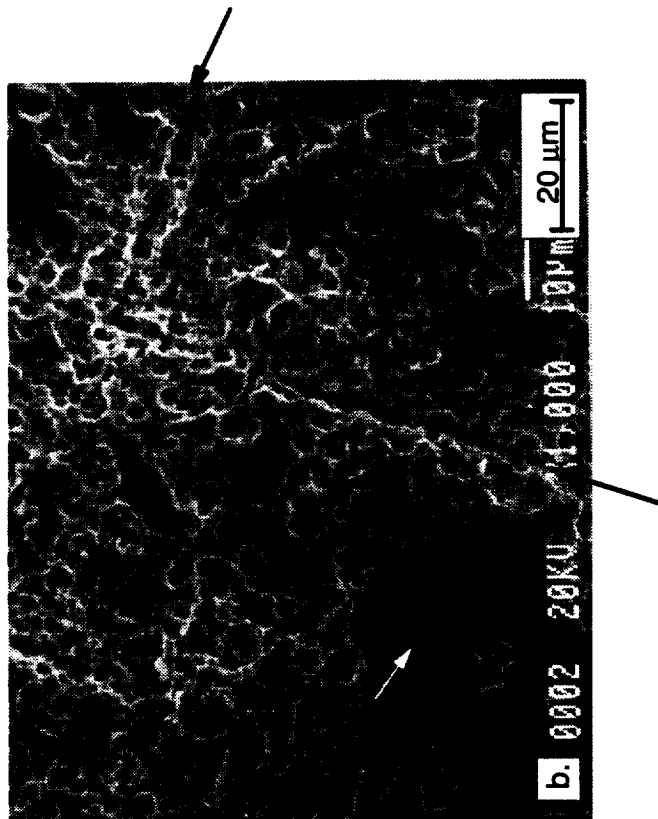
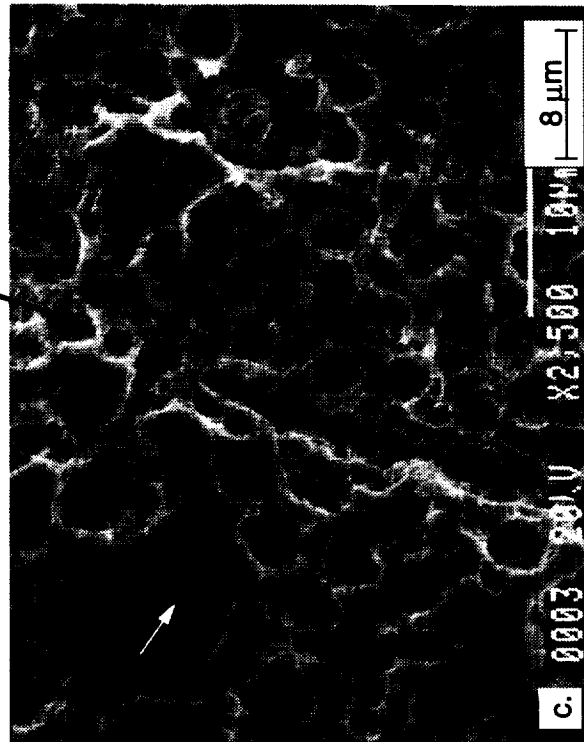
Fig. 15 SEM micrographs of D219 after chemical milling showing "less etched" regions indicated by white arrows, etch pits, and etched subgrain boundaries indicated by dark arrows.

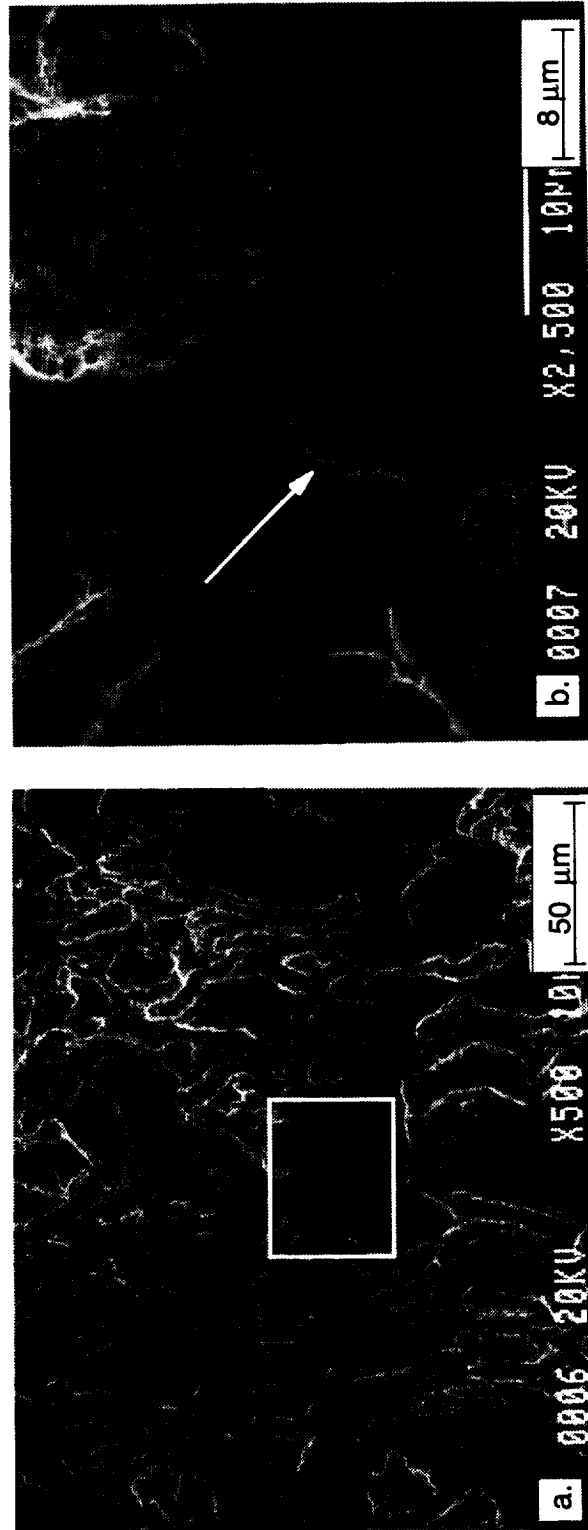
Fig. 16 SEM micrographs of D219 after chemical milling showing "less etched" regions, (b) is a higher magnification of the box shown in (a).

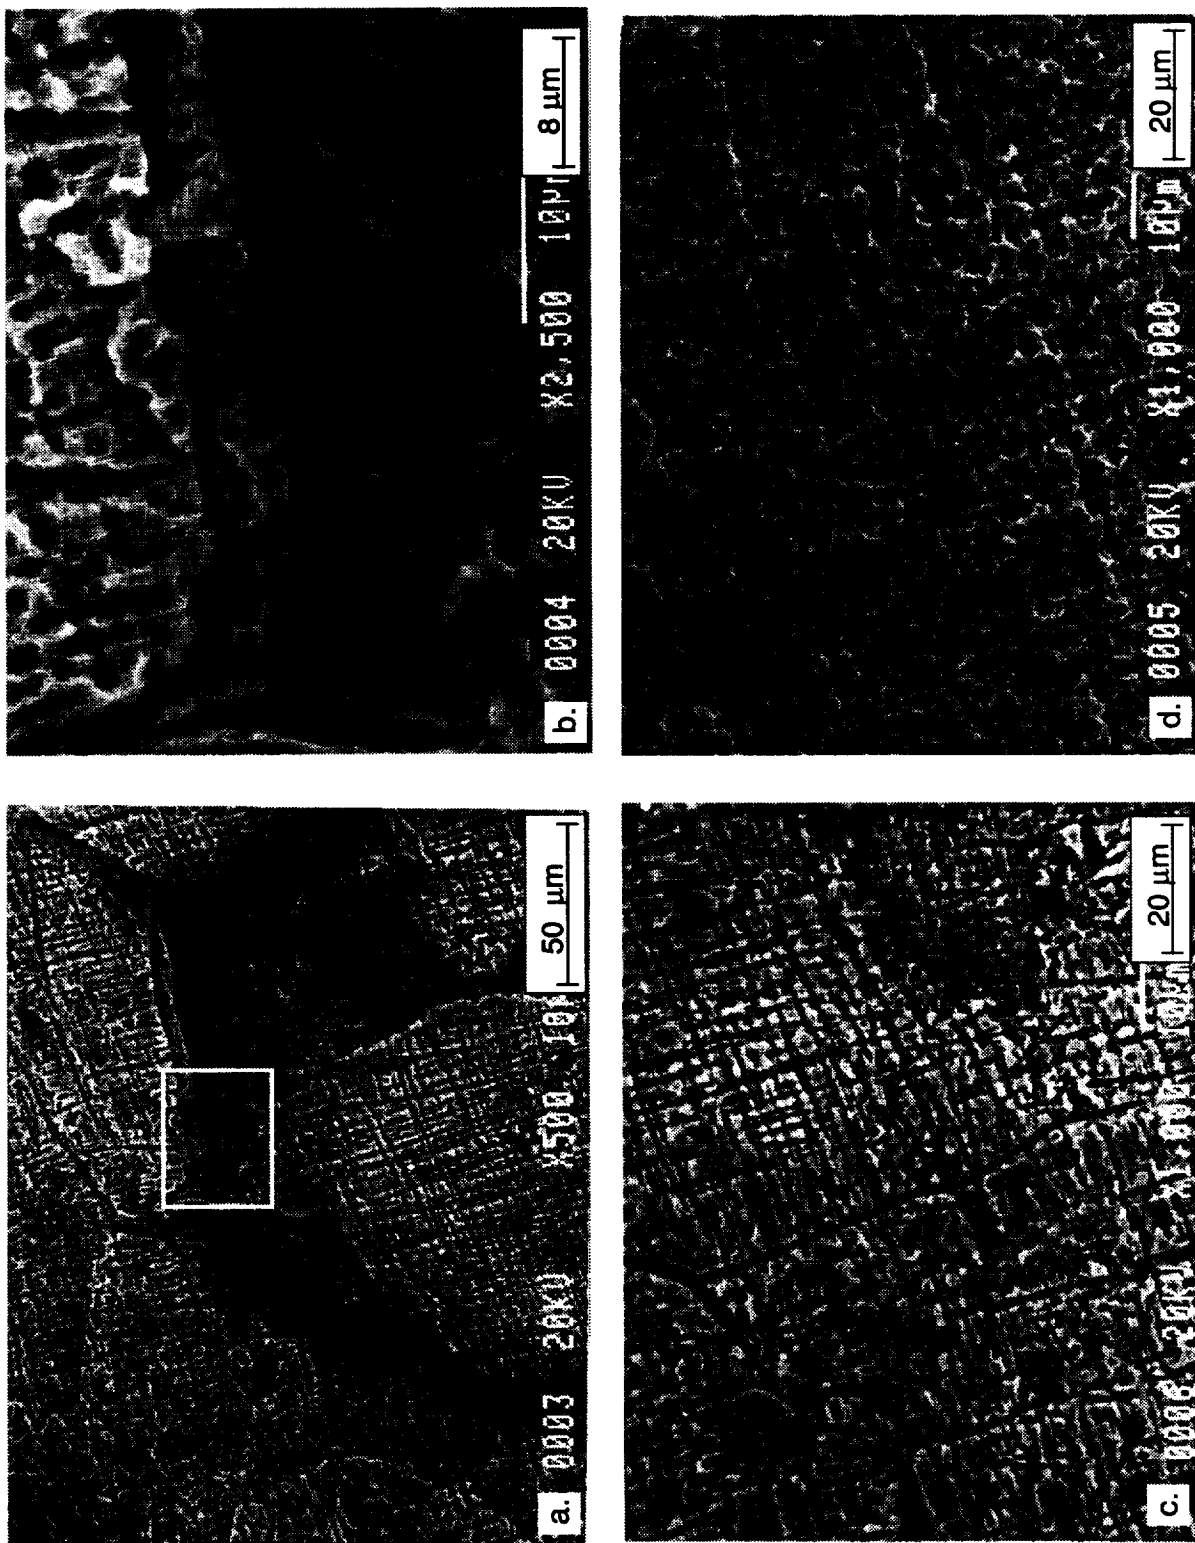
Fig. 17 SEM micrographs of D219 after chemical milling showing various morphologies of etched surface.

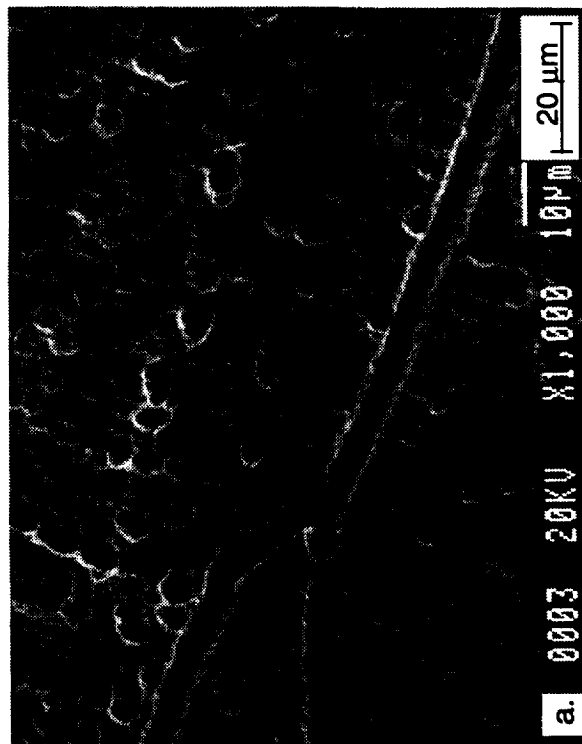
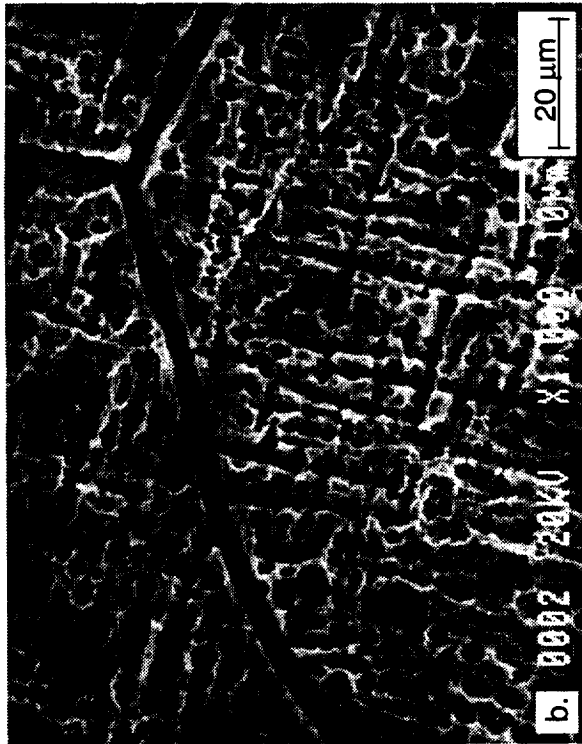
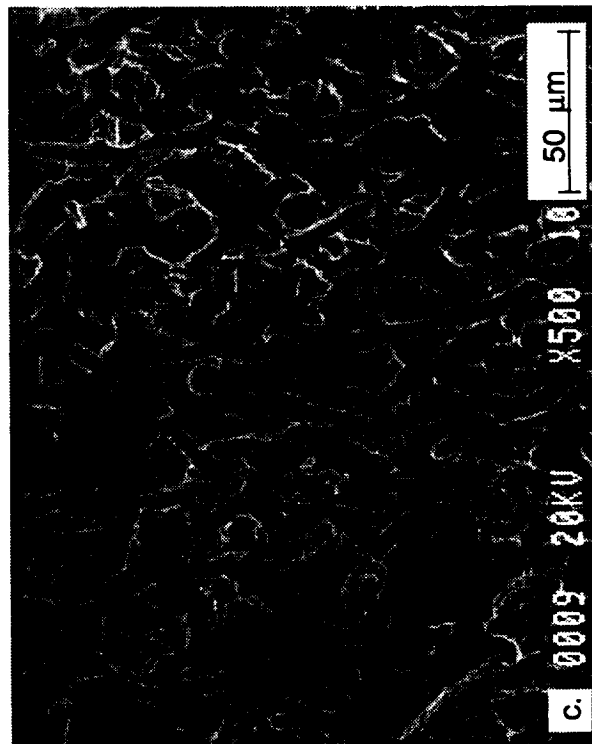
Fig. 18 SEM micrographs of D219 after chemical milling showing (a,b) etched subgrain boundaries and (c) trench-like pits.

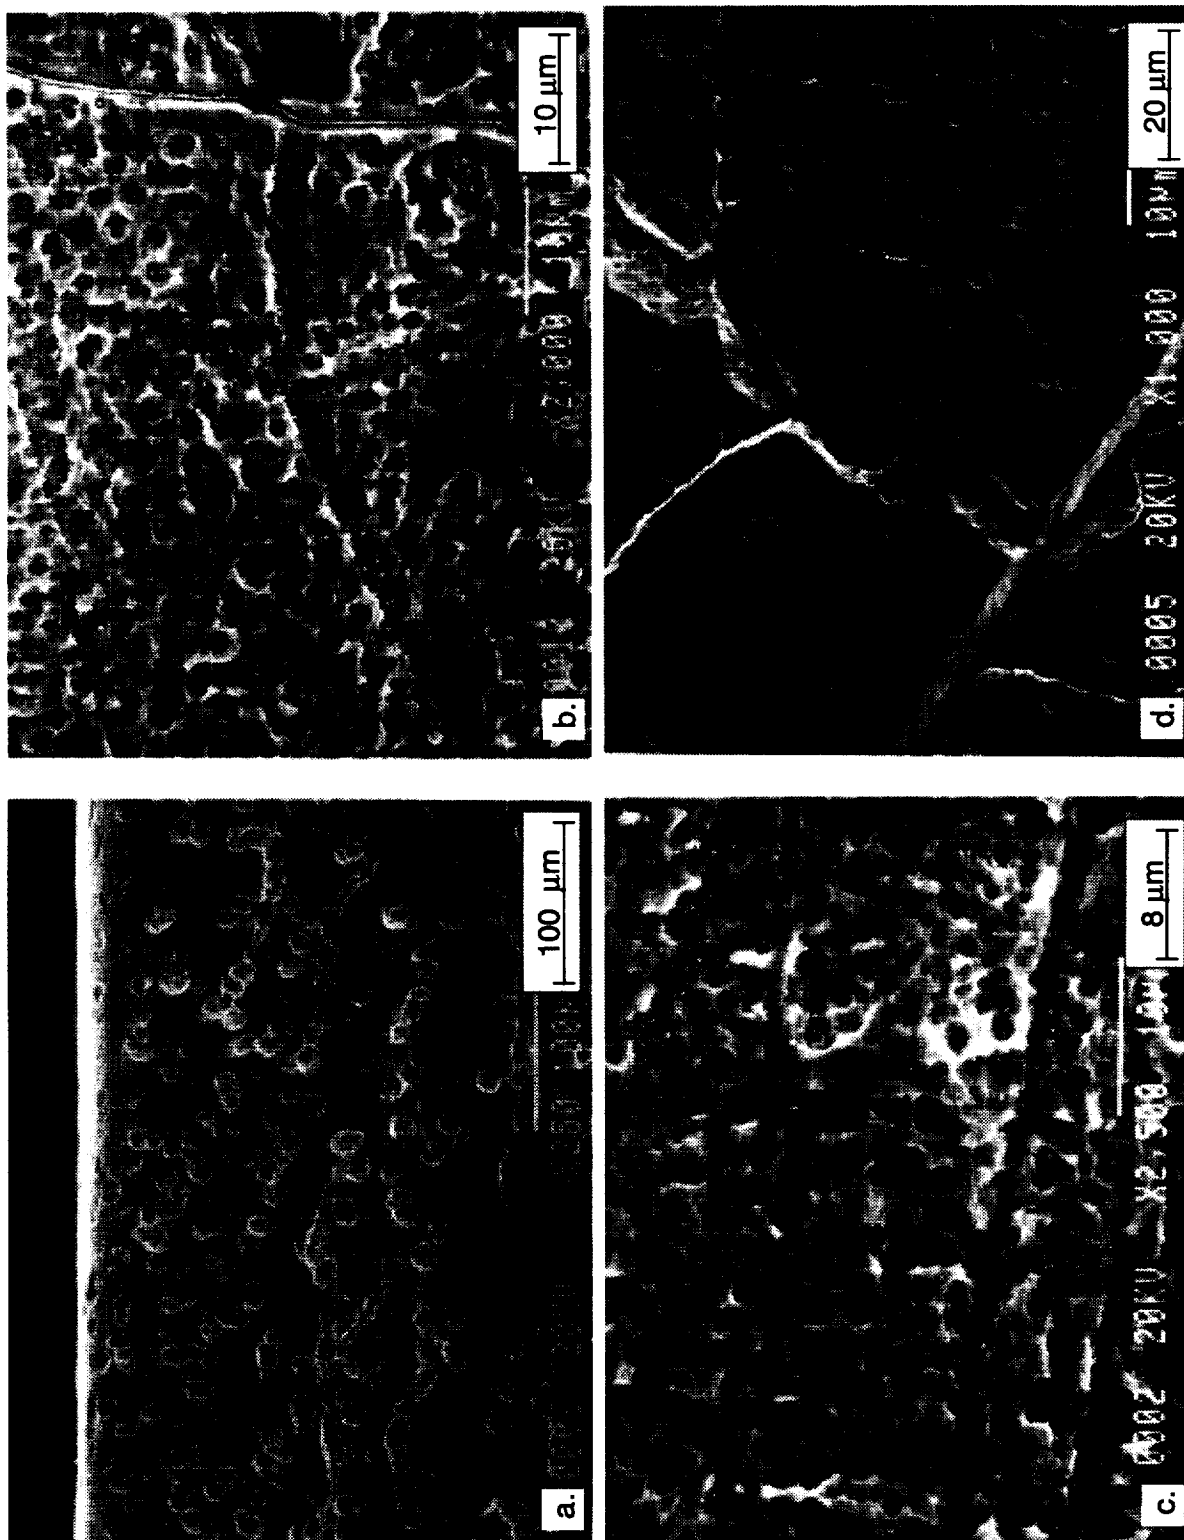
Fig. 23 SEM micrographs after electropolish and chemical milling showing pits and preferential etching of subgrains. Heusler precipitates are apparent in pits (a,b) AFN23, (c,d) AFN26.

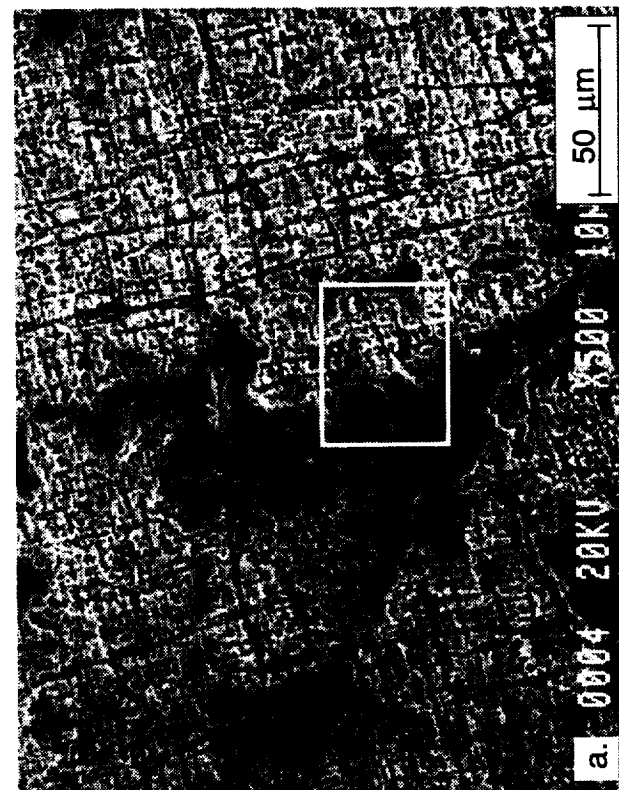
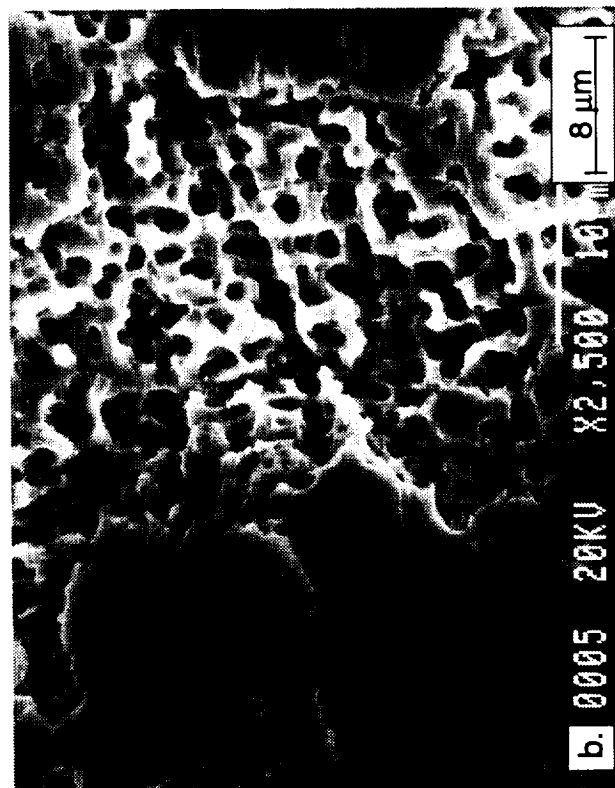
Fig. 24 SEM micrographs after electropolish and chemical milling of AFN26 showing dark regions not equally etched as surrounding material.

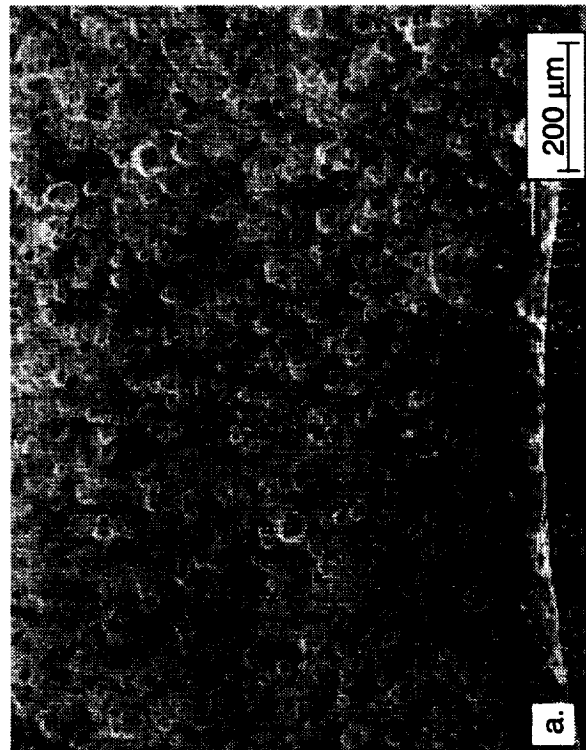
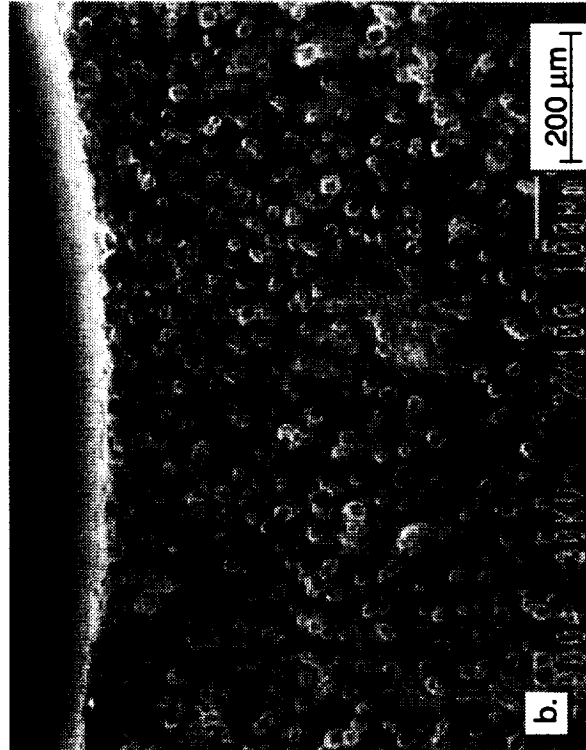
Fig. 25 SEM micrographs after electropolish and chemical milling of AFN23 showing porosity and pits on the same end of the sample.

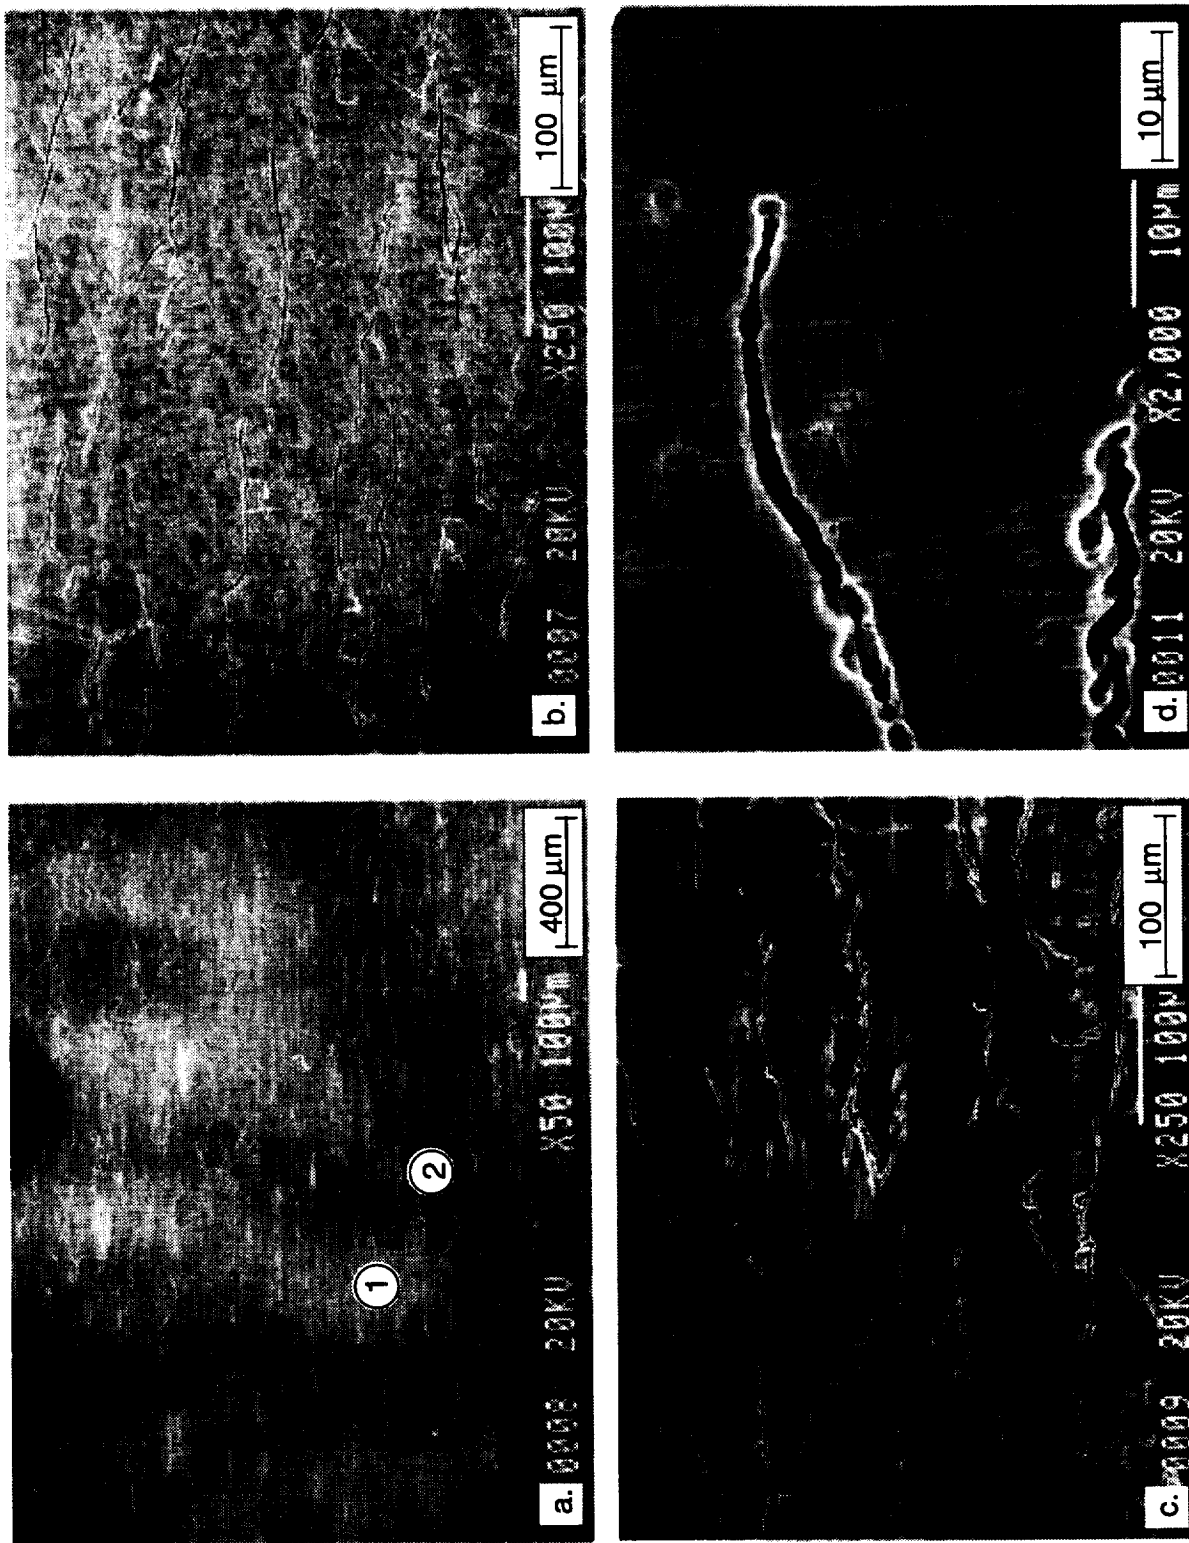
Fig. 26 SEM micrographs after electropolish and chemical milling of AFN23 (a) showing light (1) and dark (2) regions on curved surface of sample (b) magnified view of light region 1, (c,d) magnified view of dark region 2.

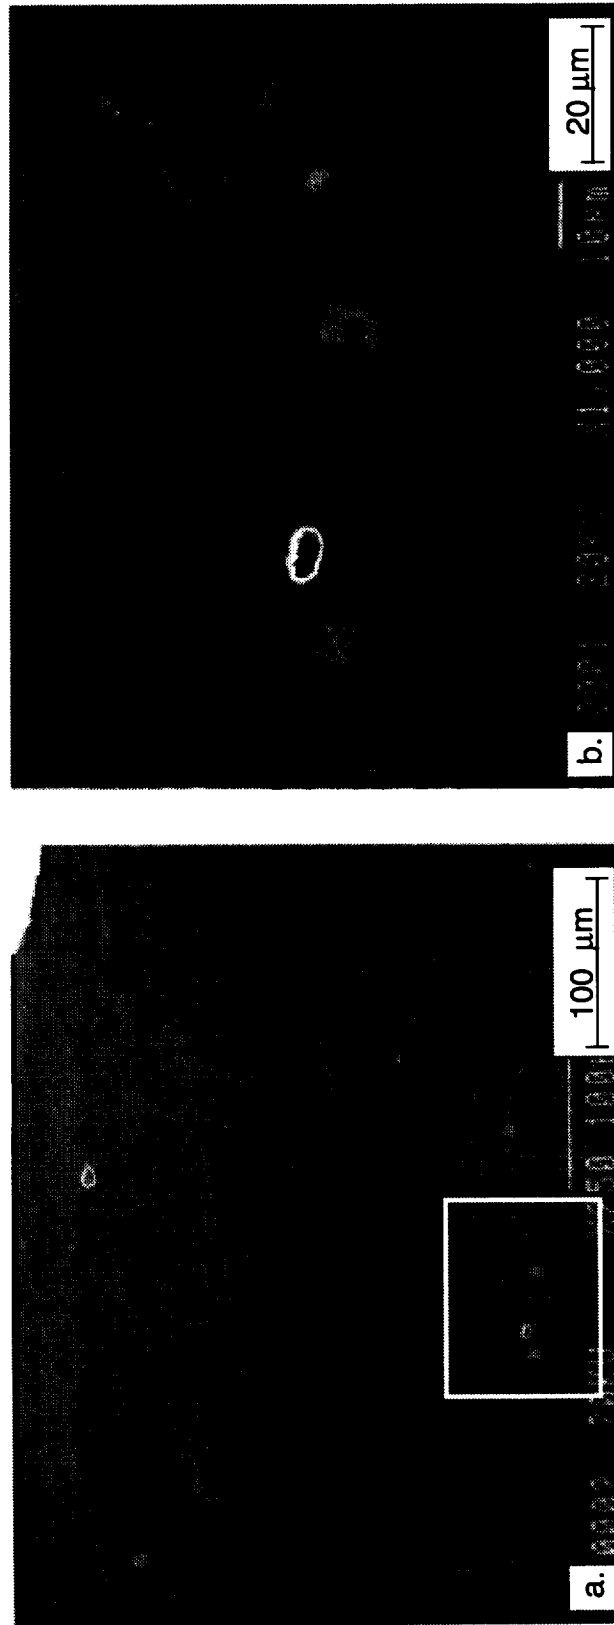
Fig. 30 SEM micrographs of D218 after mechanical polish through 600 grit SiC paper.

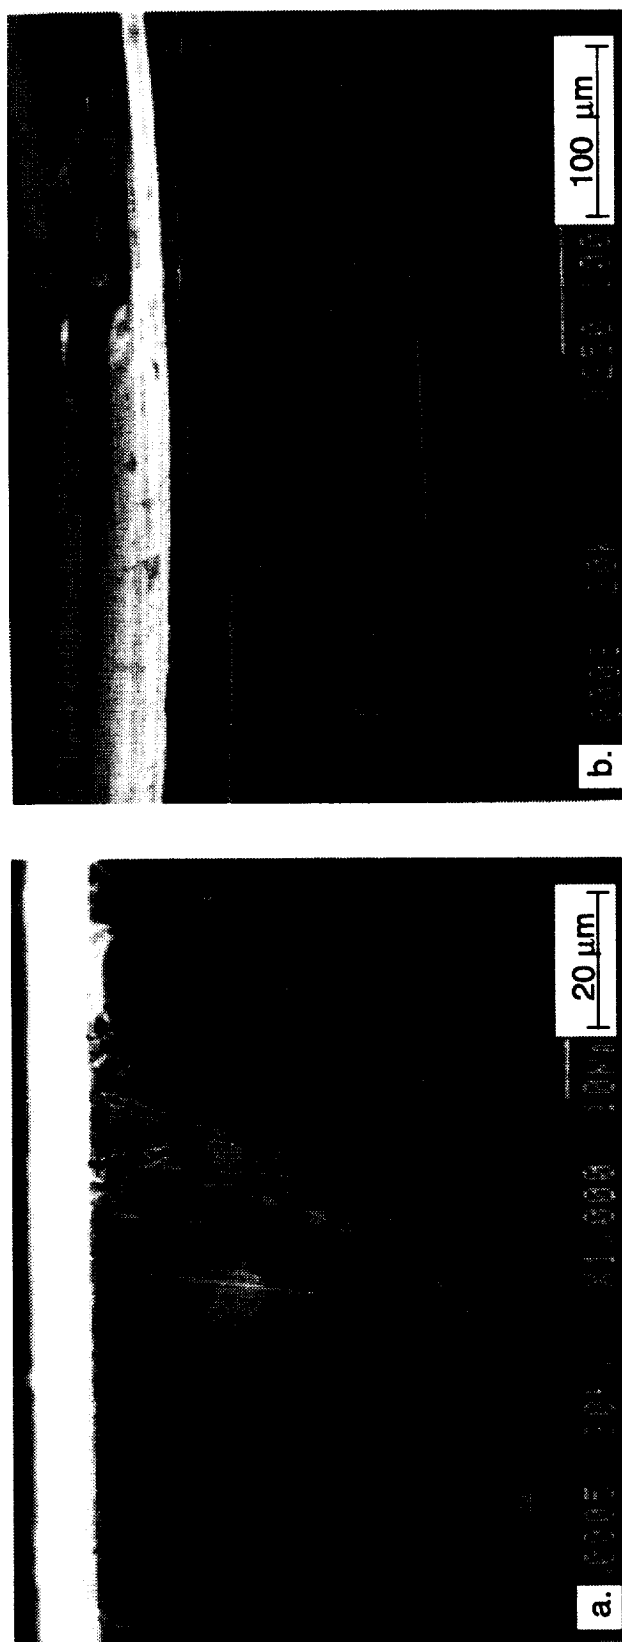
Fig. 31 SEM micrographs of D218 after mechanical polish through 600 grit SiC paper showing polishing marks remaining on the surface.

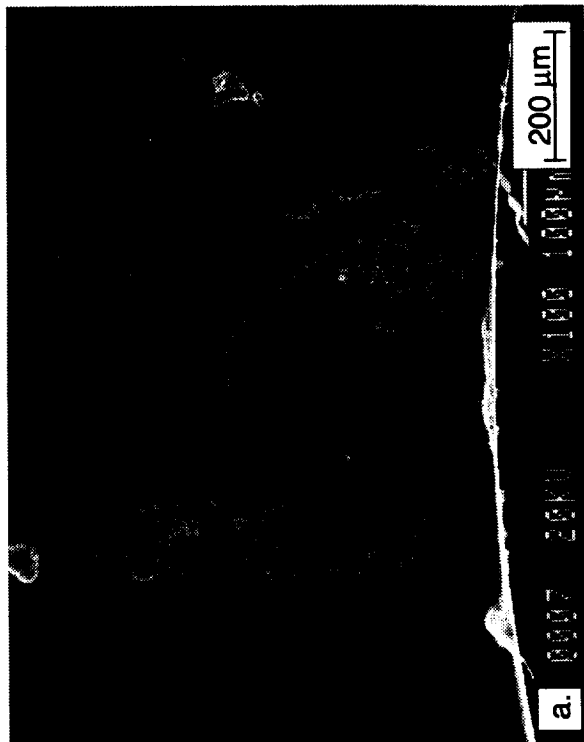
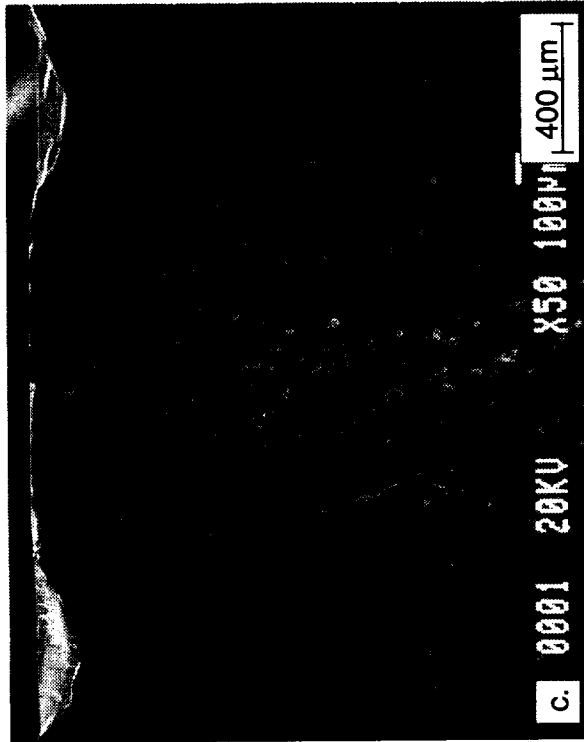
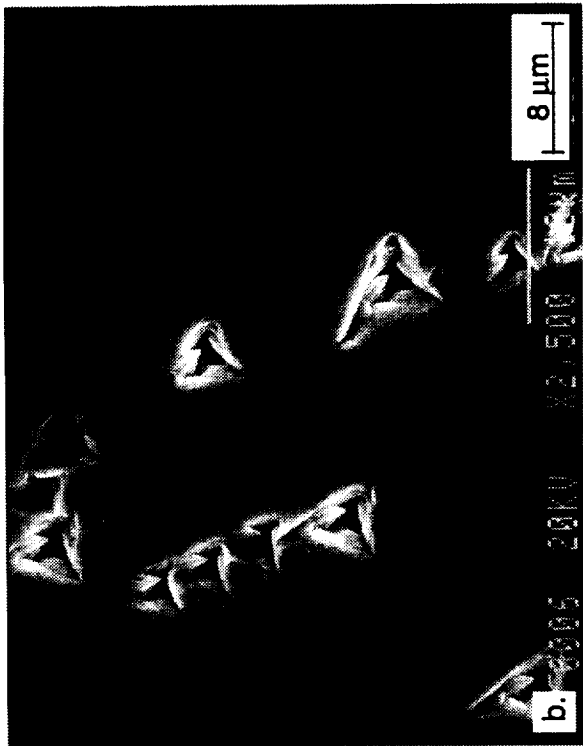
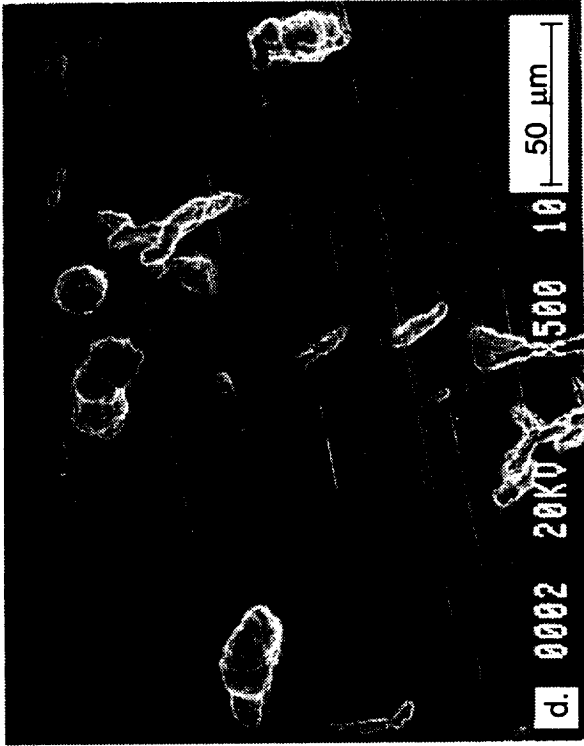
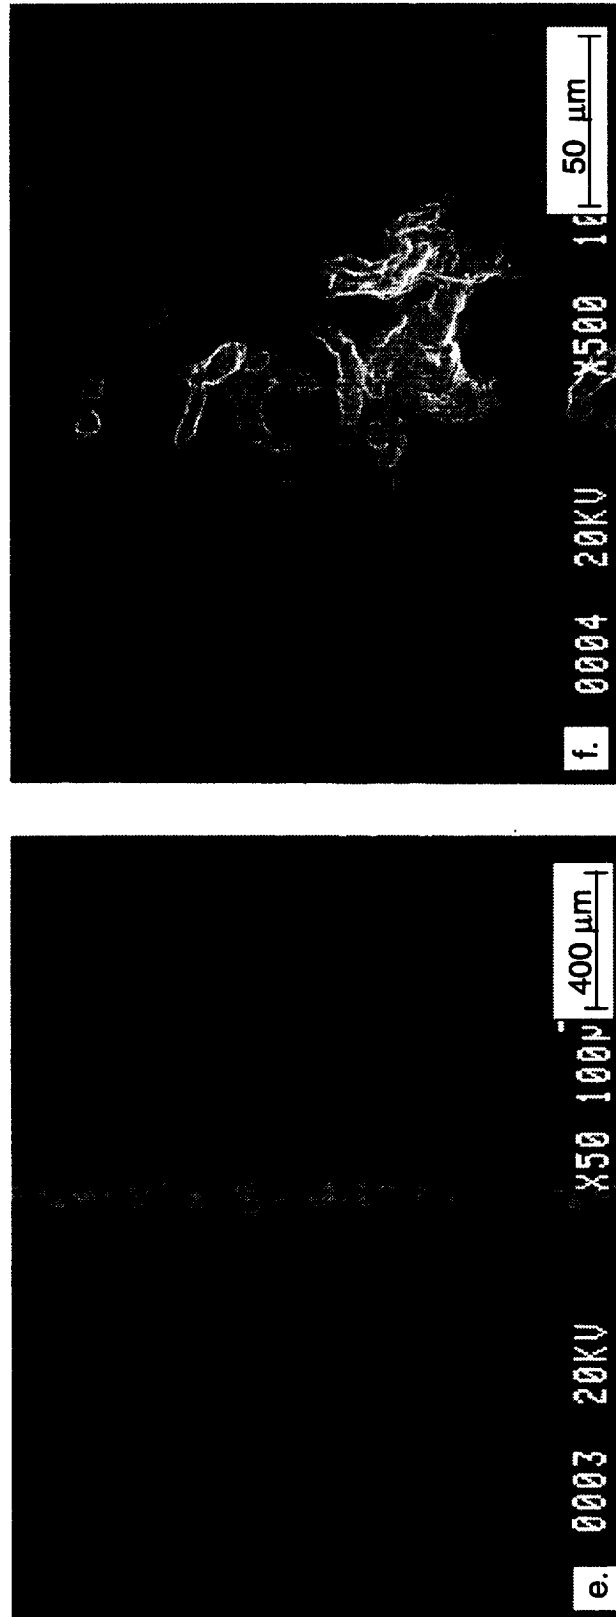
Fig. 32 SEM micrographs after mechanical polish showing fine pores remaining on the surface of (a,b) D218, (c,d,e,f) D219. Images (b,d and f) are magnified views of pores in (a,c and e).

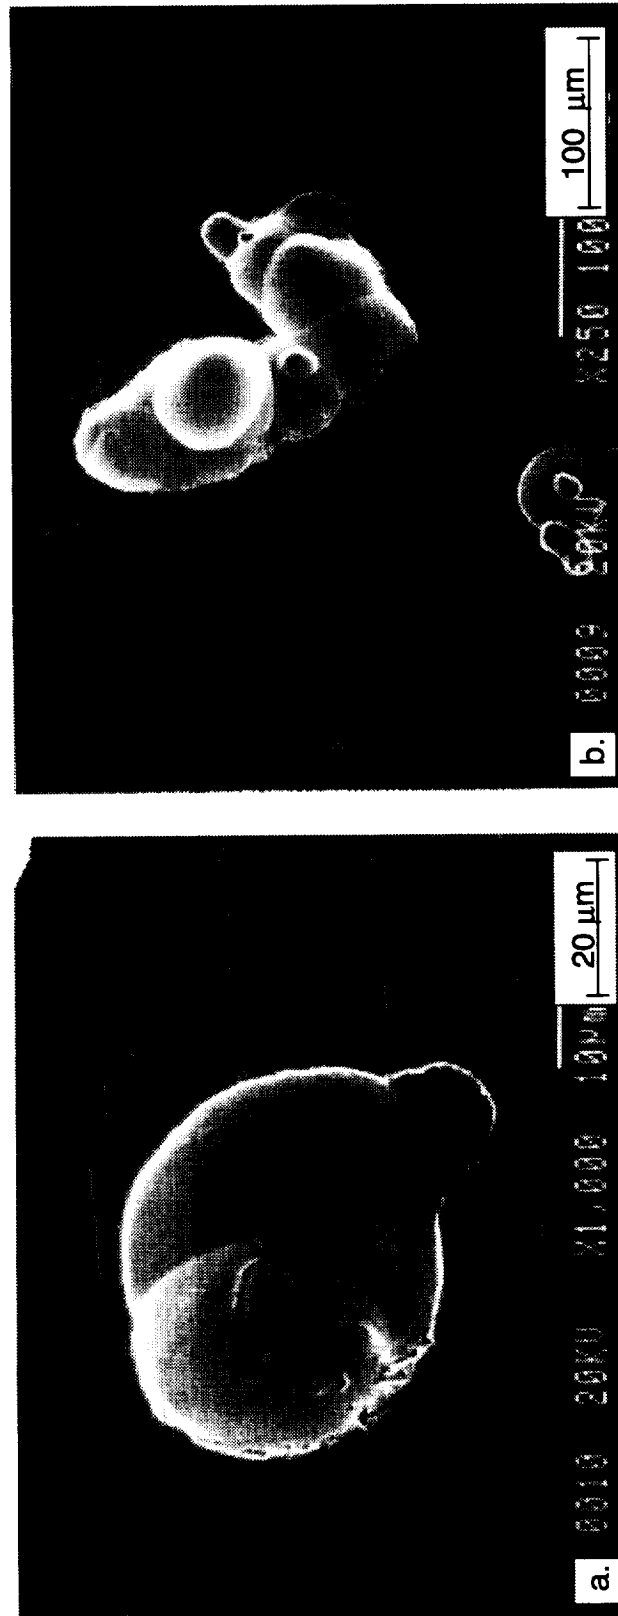
Fig. 33 SEM micrographs after mechanical polish showing large pores remaining on the surface of D218.

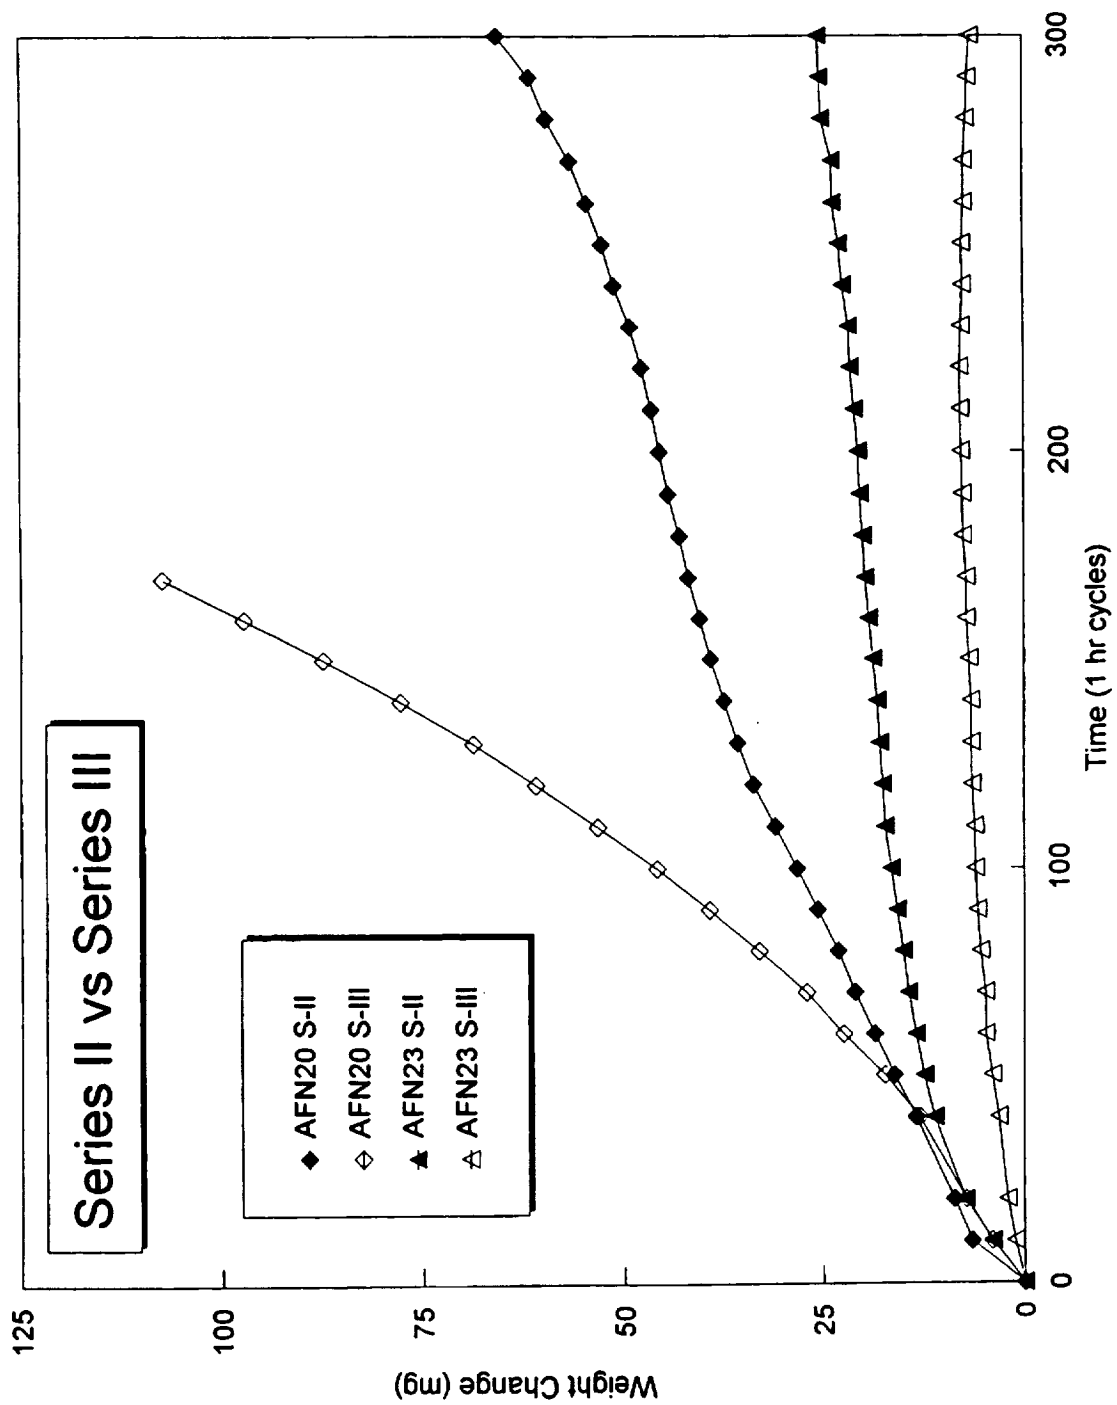
Fig. 36 Weight change during burner rig testing for Series II versus Series III for AFN20 and AFN23 alloys.

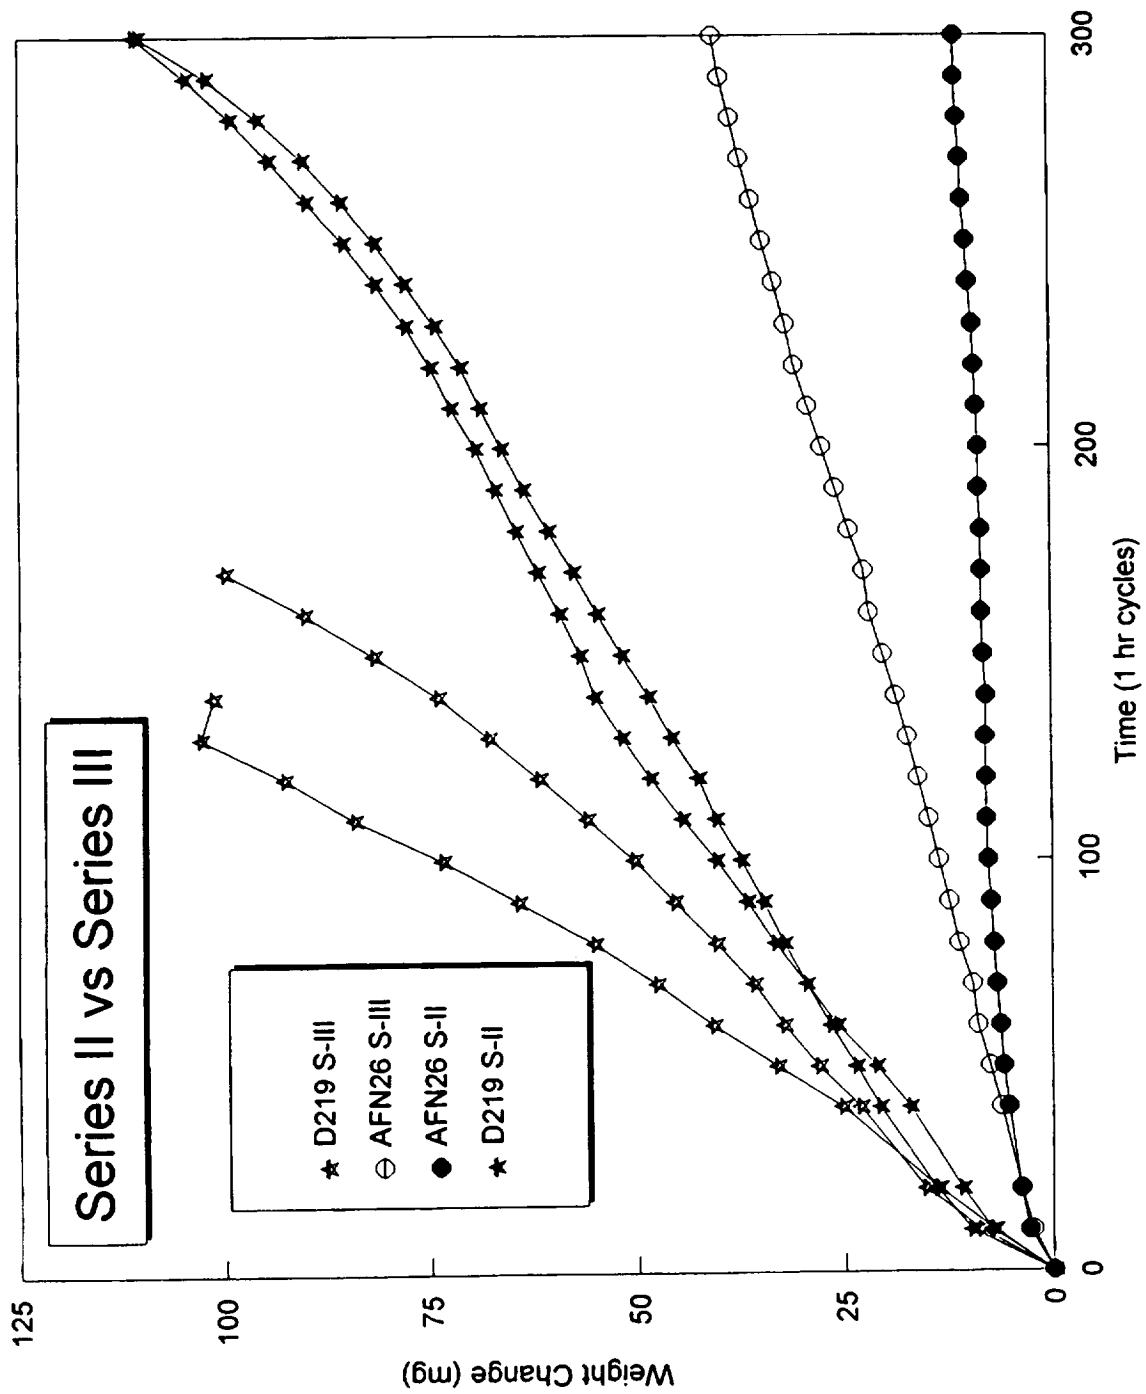
Fig. 37 Weight change during burner rig testing for Series II versus Series III for AFN26 and D219 alloys.
